NWC TP 5430

ESKIMO I Magazine Separation Test

Frederick H. Weals
Engineering Department

Naval Weapons Center

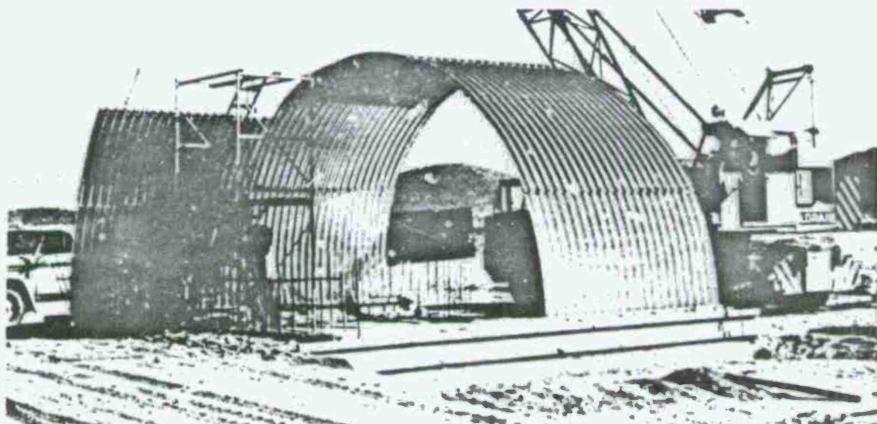
FIG. 4. Construction of Acceptor Igloo. Showing Attachment of Steel Arch.

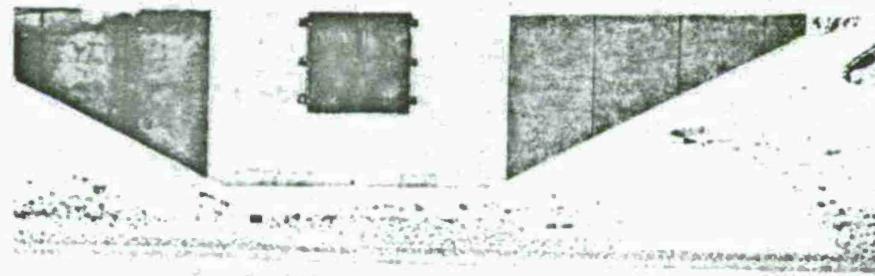
FIG. 5. BOWING FORWARD LEVERWALL AT RECEIVER DOOR.

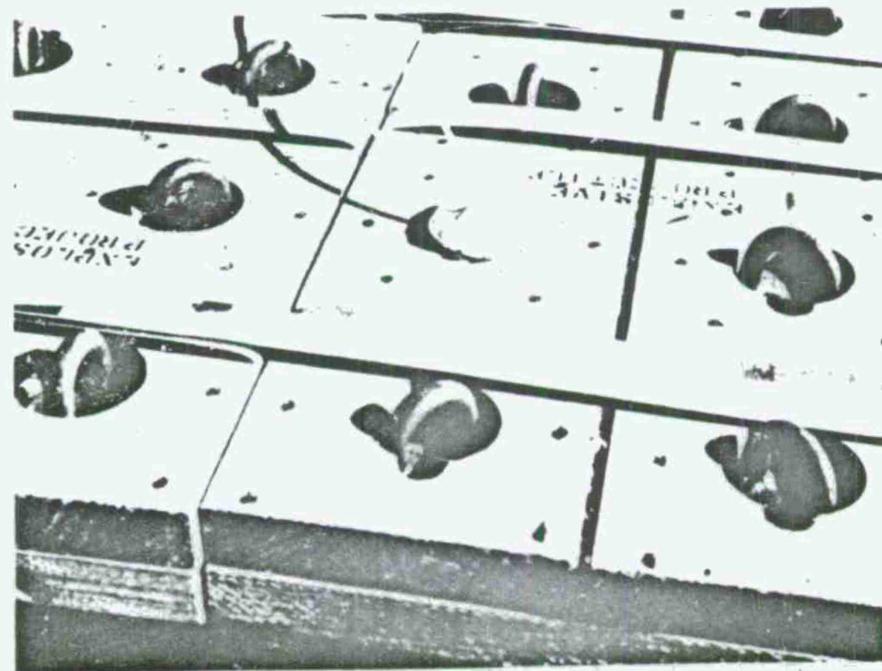
Selected projectiles in the ammunition stack were primed by packing high explosive (Composition C) in the projectile fuze well (Fig. 11) and equipping each with a length of Primacord leading to a nonelectric detonator. Primed projectiles were located at each of the eight corners (upper and lower) of the bottom layer, which was two pallets high, of the ammunition stack. Interior projectiles on the pallets were chosen, so that each primed projectile was surrounded by unprimed ones. Primed projectiles were also placed in each of the five layers of pallets in a column in the center of the stack. Since there was no access to the rear of the igloo after the ammunition was installed, the projectiles were primed as the pallets were loaded in, and the Primacord leads were brought forward during the loading process. All 13 Primacord leads had the same total length and the same length extending outside the magazine; these exterior lengths were bundled.

FIG. 11. Primed Projectile With Other Projectiles in Pallets.

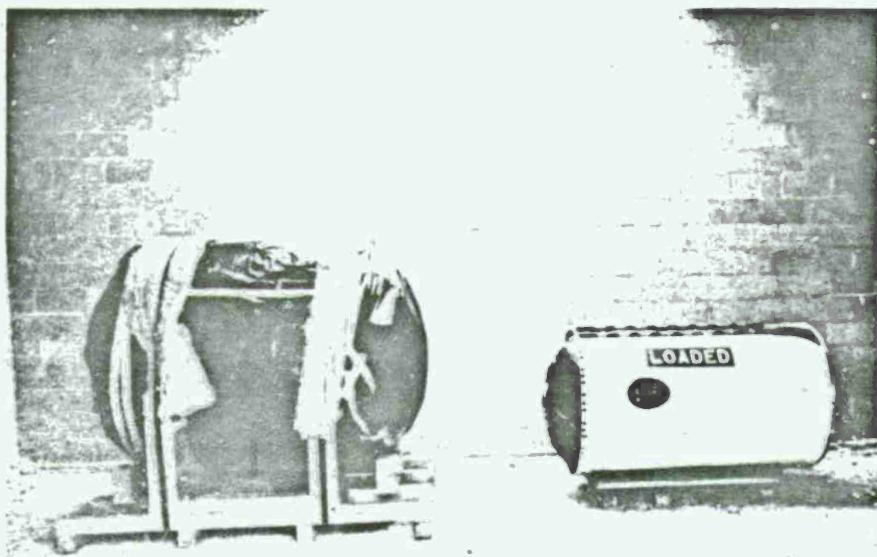
FIG. 12. Northwest Storage Building With Rocket Motors in Place. Polaris motor is on the left, Minuteman on the right. The missing roof section was replaced before the test.

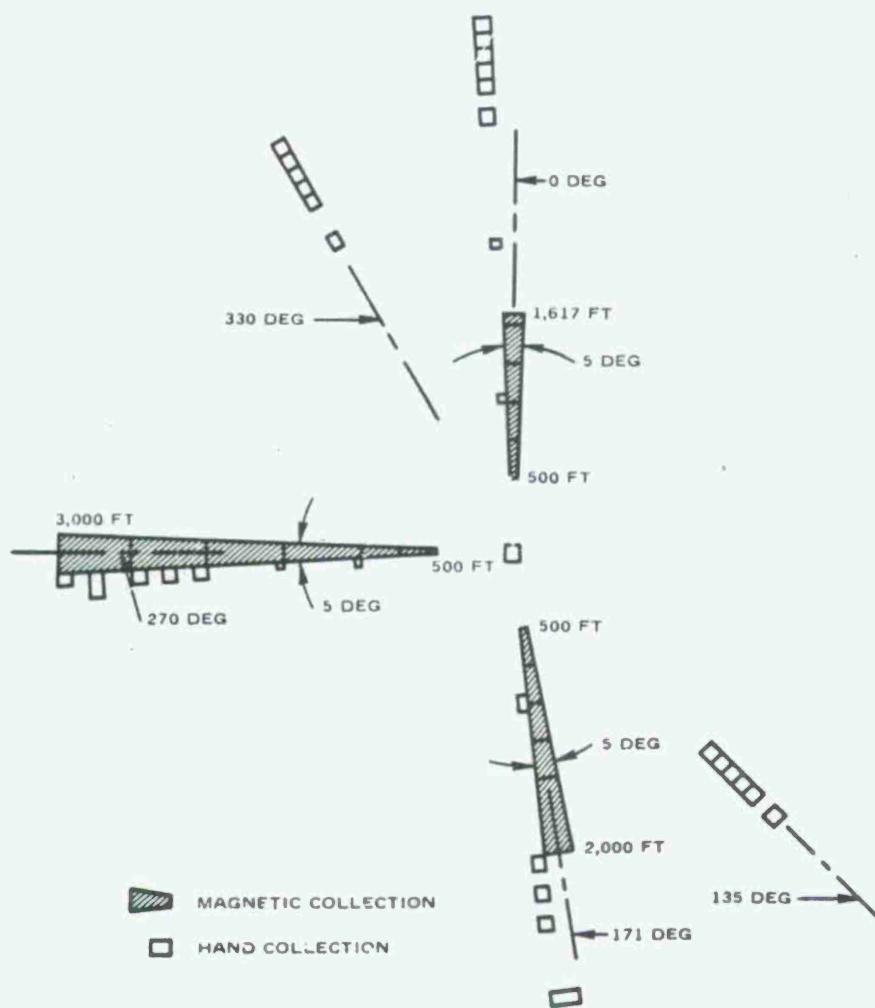
To measure fragment distribution, three radial sectors of 5-degree width were cleared and smoothed to the north, south, and west of the donor magazine, beginning at a distance of 500 feet from the magazine (Fig. 13). The south and west sectors were cleared to 3,000 feet, although the south section was searched

only to 2,000 feet. The north sector ended at 1,617 feet because of a hill. The south sector actually extended along 171 degrees true, not 180, to avoid a hill. Each sector was divided into several search areas called cells.

In addition, a number of search areas, mostly 100-foot squares, were surveyed and marked but not cleared. These areas were located adjacent to and beyond the three sectors and also on lines extending 135 and 330 degrees true from the donor magazine center. Some of the areas shown in Fig. 13 were added after the test. The general plan was to search these small areas on foot and to search the cells with a magnet truck.

FIG. 13. Fragment Collection Areas.

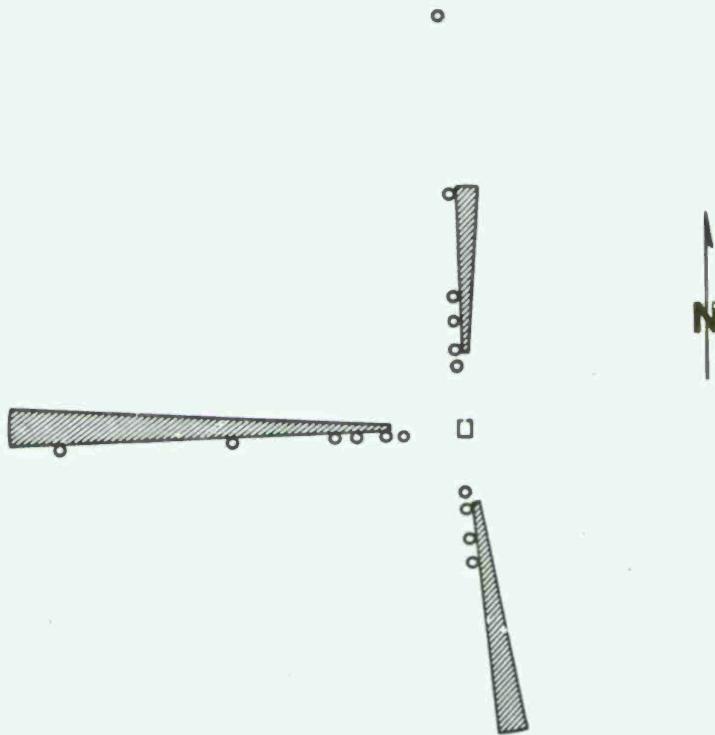
structures, 16 Ballistics Research Laboratories self-recording blast gauges, were installed from 410 feet to 2,690 feet to the north and west of the donor magazine, and from 410 feet to 880 feet to the south. These were installed along the edges of the cleared sectors, as shown in Fig. 14.

EXPECTED OVERPRESSURE AT 410 FT: 20 PSI
EXPECTED OVERPRESSURE AT 2,690 FT: 1 PSI

FIG. 14. Blast Gauge Locations.

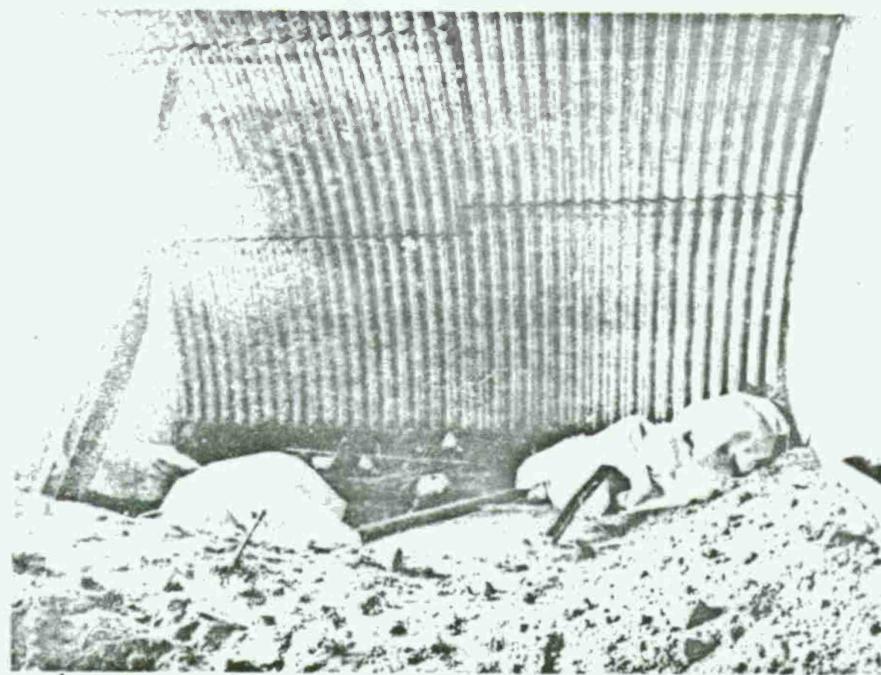
1. The doors were forced inward (Fig. 32). They remained in a generally upright position although hinge separation occurred at several points.
2. Earth cover from the donor magazine was thrown into the igloo (Fig. 33) and also against the headwall and wing walls.
3. The concrete headwall was cracked, particularly around the door frame, from blast overpressure but showed little evidence of fragment damage (Fig. 34).

FIG. 32. Interior View of South Igloo.

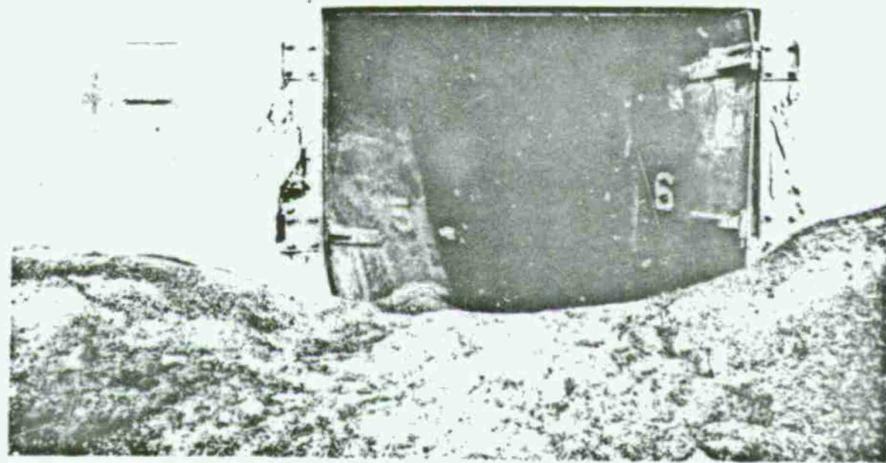
FIG. 33. Headwall and Doorway of South Igloo.

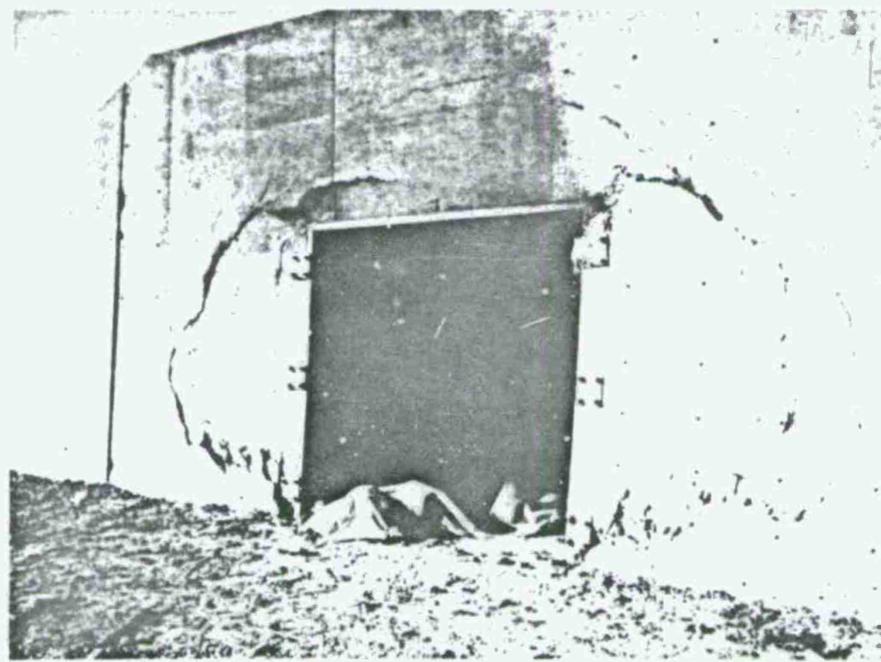
1. The doors were forced inward and detached from their hinges. Sheet metal door liners were separated.
2. Headwall cracking was much more general than in the south or west igloos. Cracking and inward movement was particularly more evident just inward of the line of attachment to the steel arch, the concrete sill, and concrete floor (Fig. 39 and 40). Despite this more extensive damage, there were only very limited areas of concrete separation, or spalling, from the interior surface of the wall. Together with the nature and position of the separation and with low wall velocities of approximately 35 ft/sec, this limited amount of spalling indicated that the secondary concrete fragments would have presented no serious hazard to ordnance in the igloo. Figure 41 shows the linear motion transducer used to derive the wall velocity.

FIG. 39: Headwall of North Igloo. Note crack pattern approximating shape of steel arch.

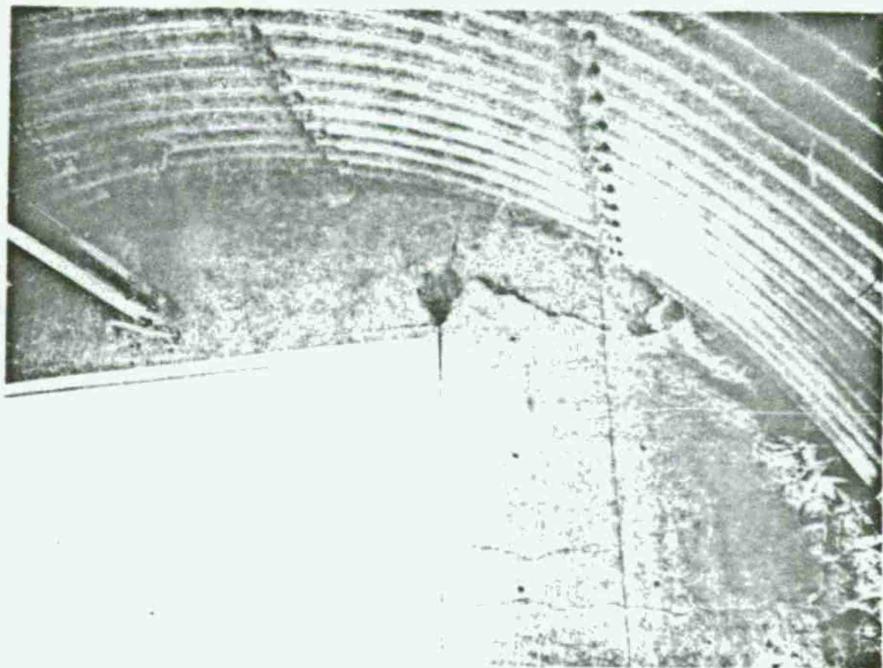
FIG. 41. Upper Headwall of North Ditch. Shows Erosion Marks, Pendulum, and Its Pendulum Mounting.

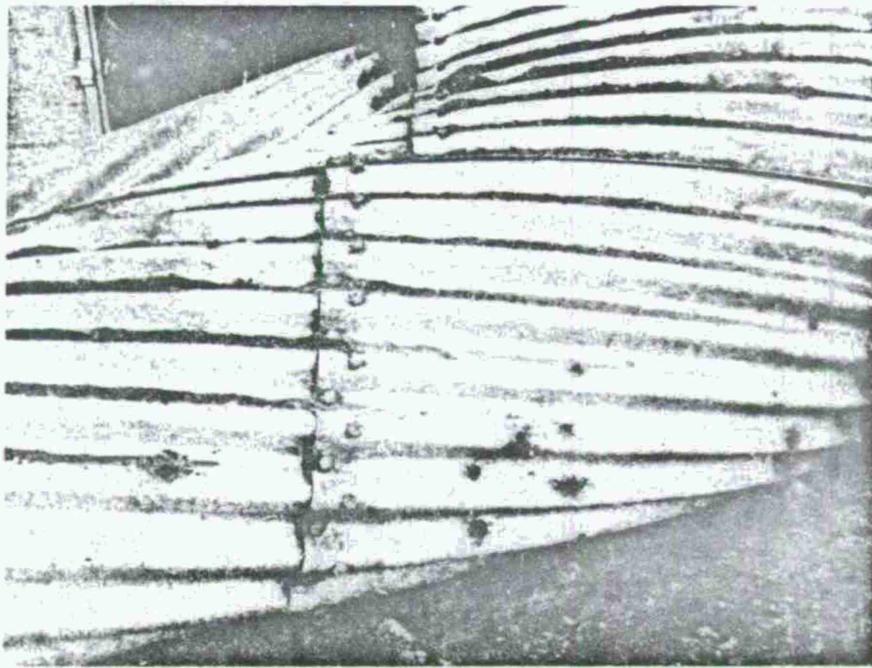
FIG. 44. Part of Steel Arch of East Igloo Lying in Front of Door of 59-Foot Magazine.
Note perforations from acceptor fragments.

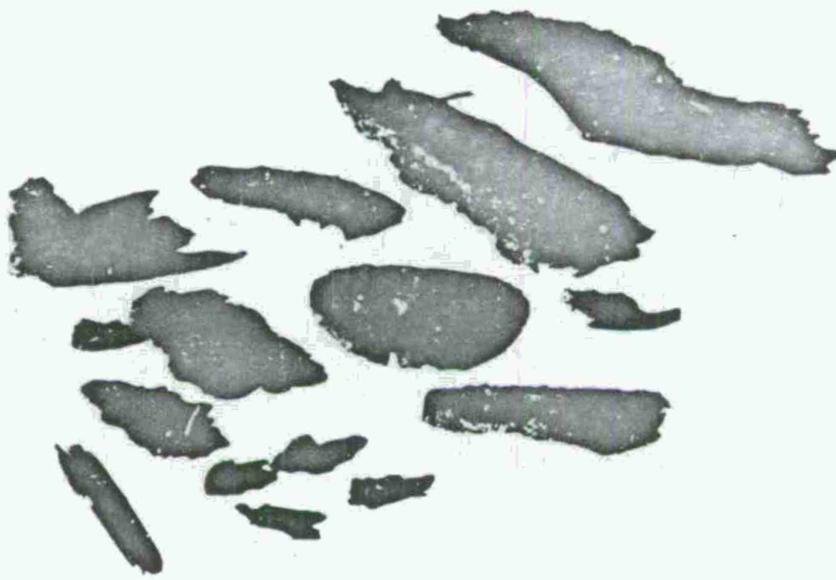
The aircraft skin was pierced by fragments in 42 places (Fig. 47). Fragments found about the aircraft, which was parked 1,800 feet from the donor magazine, varied in size from small gravel to about 10 pounds in weight (Fig. 48).

FIG. 48. Projectile Fragments Found at Site of B-29 Aircraft. The largest fragment shown here weighed 10 pounds.

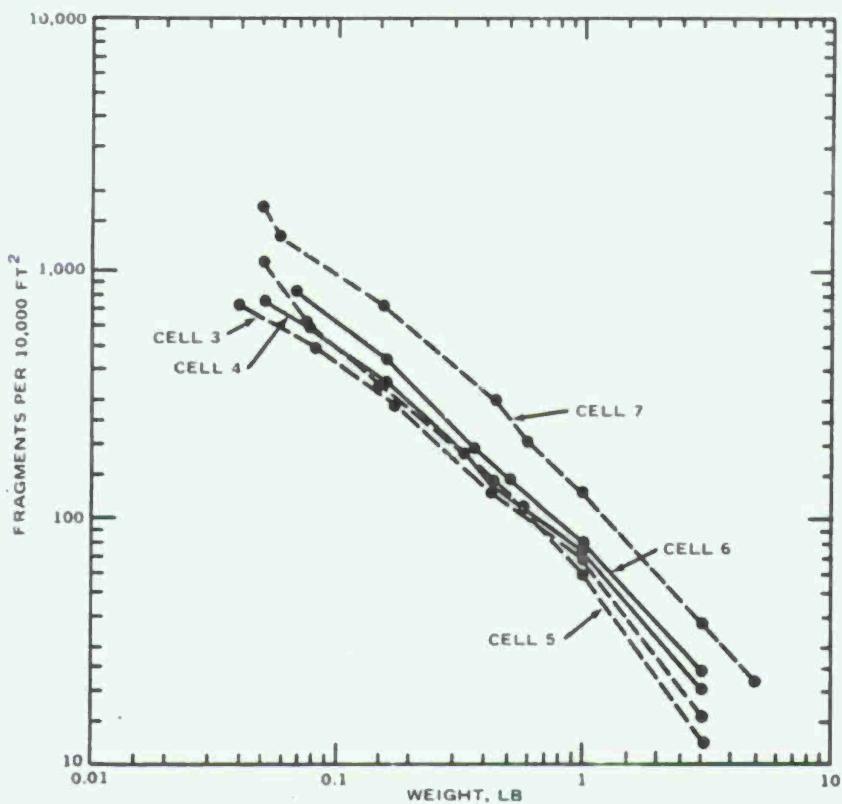
FIG. 50. Cumulative Number of Fragments per 10,000 ft² Versus Weight in Pounds for Cells in the North Sector (Magnetic Pickup). Rough, hilly terrain prevented magnetic pickup in Cells 1 and 2.

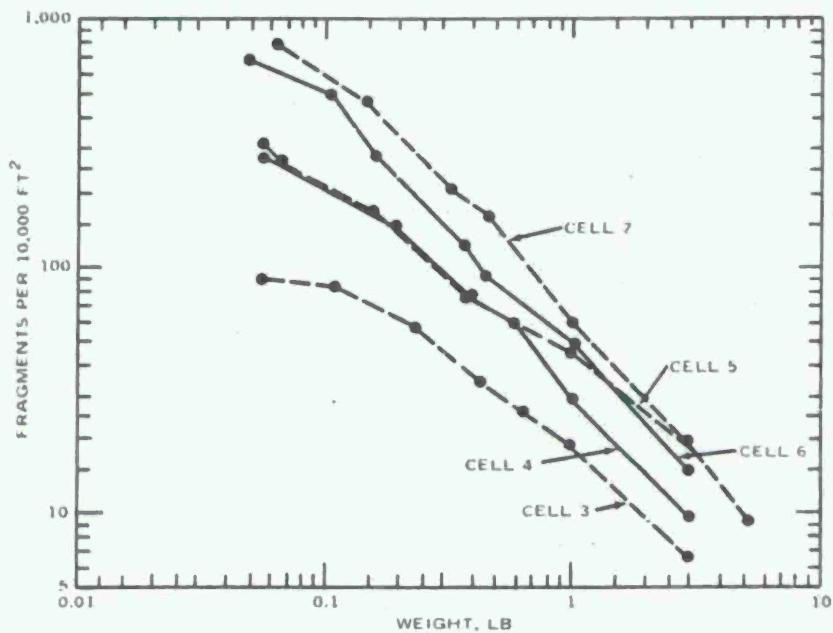
FIG. 51. Cumulative Number of fragments per 10,000 ft² Versus Weight in Pounds for Cells in the South Sector (Magnetic Pickup). Cells 1 and 2 were too soft for the truck to operate in.

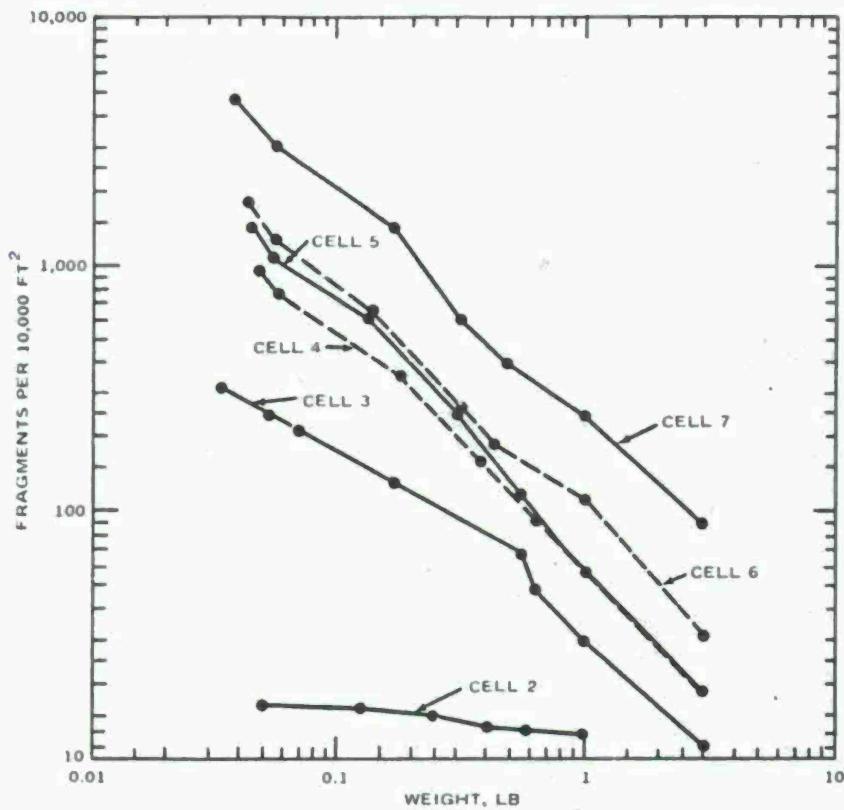
FIG. 52. Cumulative Number of Fragments per 10,000 ft² Versus Weight in Pounds for Cells in the West Sector (Magnetic Pickup). Data for Cell 1 is off scale in this figure.

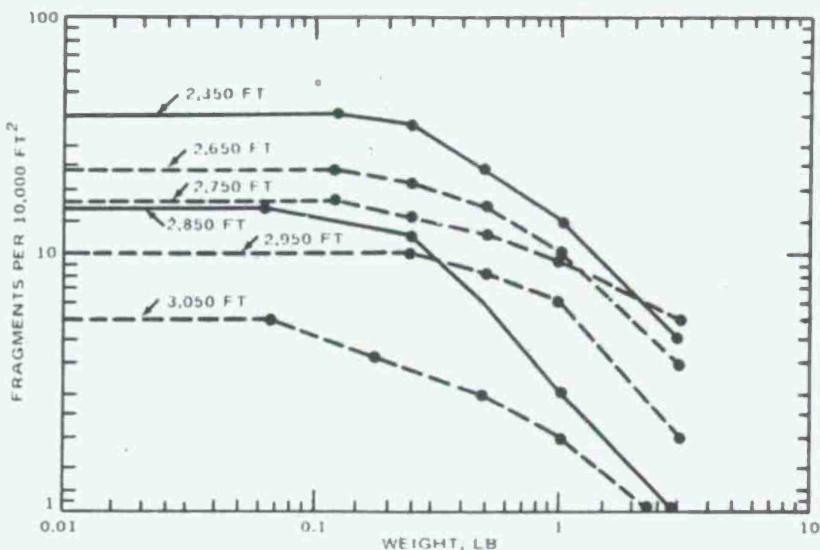
FIG. 53. Cumulative Number of Fragments per 10,000 ft² Versus Weight in Pounds for Various Northwesterly Distances From the Donor Magazine (Hand Pickup).

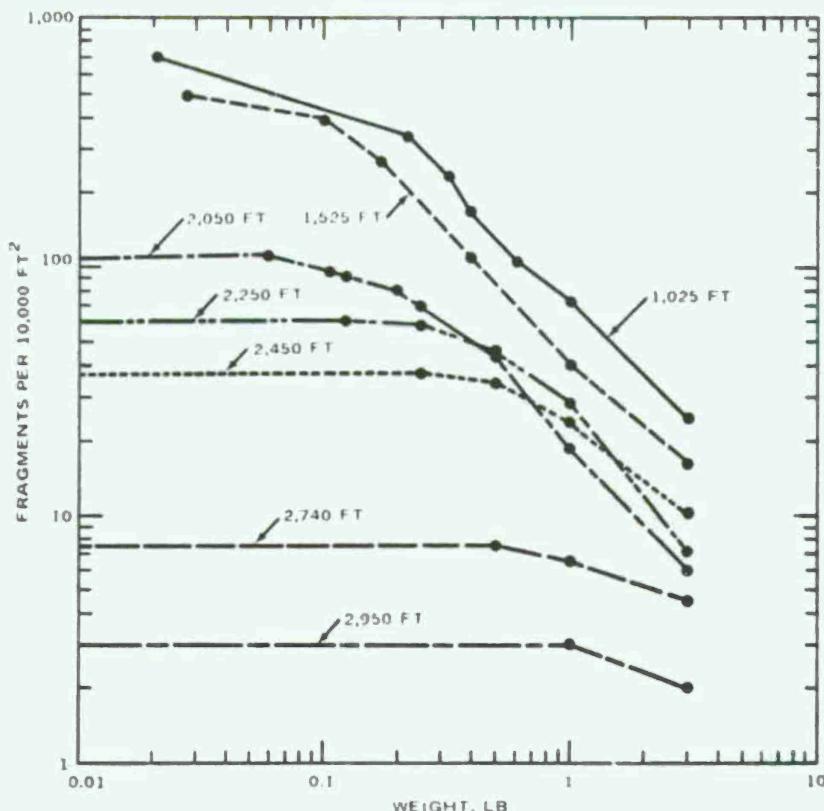
FIG. 54. Cumulative Number of Fragments per 10,000 ft² Versus Weight in Pounds for Various Westerly Distances From the Donor Magazine (Hand Pickup).

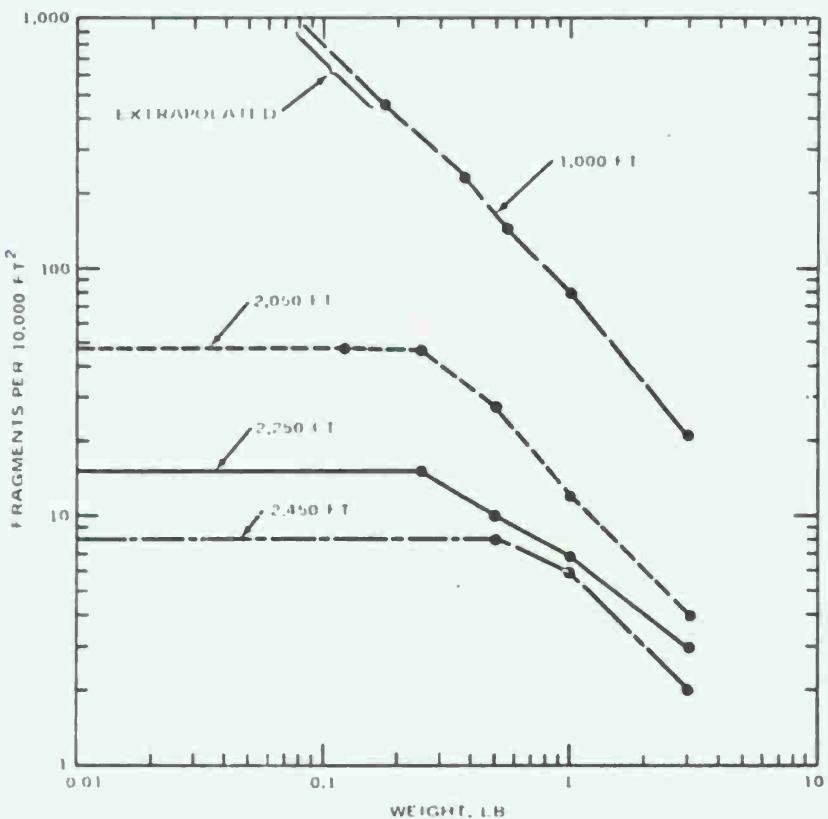
FIG. 56. Cumulative Number of Fragments per $10,000 \text{ ft}^2$ Versus Weight in Pounds for Various Southerly Distances From the Donor Magazine (Hand Pickup). The 1,000-foot curve was extrapolated to obtain a 0.125-pound data point for use in calculations.

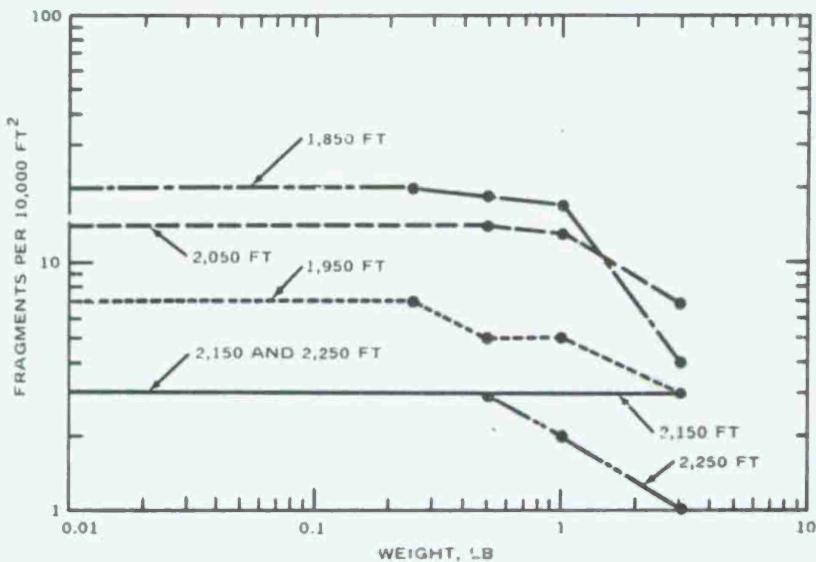
FIG. 57. Cumulative Number of Fragments per 10,000 ft² Versus Weight in Pounds for Various Southeasterly Distances From the Donor Magazine (Island Pickup). The 100-by 100-foot area at 2,450 feet was searched, but no fragments were found in it.

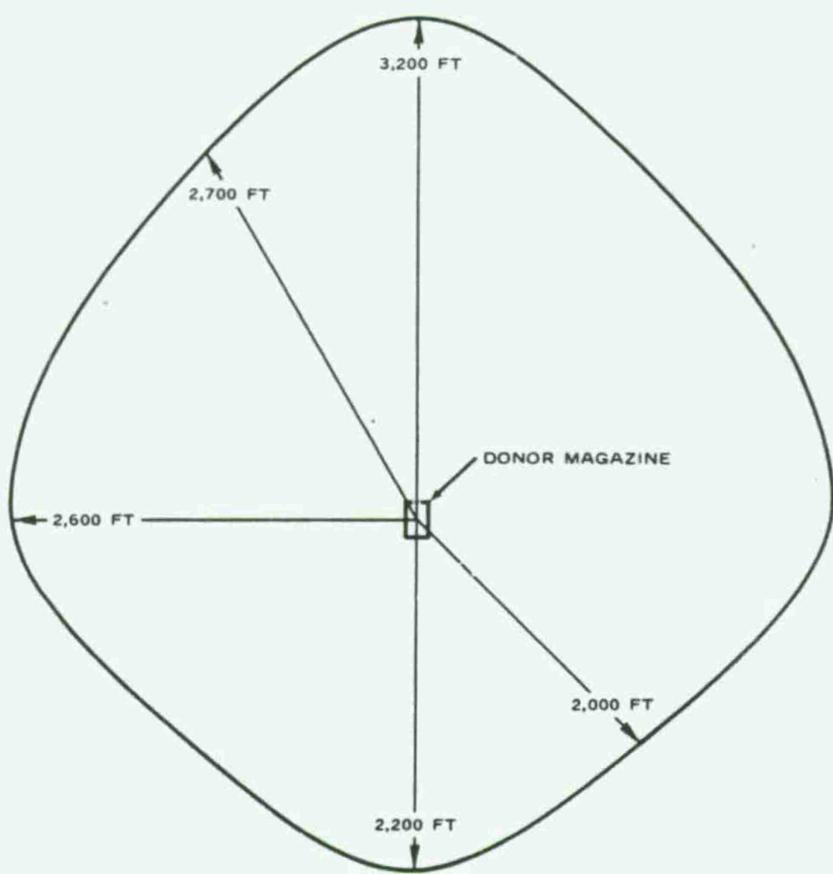
2. The distribution of fragments in this test made it apparent that the safe fragment distance based on the above criterion would be determined by fragments falling at their free-fall terminal velocity. From Fig. 3 of Ref. 2, the value of 0.28 pound was derived as the weight of a 58-ft-lb fragment moving at terminal velocity. Figure 66 shows the limits of fragment hazard for the ESKIMO I test, based on the above standards.

FIG. 66. Limits of Fragment Hazard, Based on Acceptable Density of One Hazardous Fragment per 600 ft^2 . A hazardous fragment is defined as one having kinetic energy $> 58 \text{ ft-lb}$.

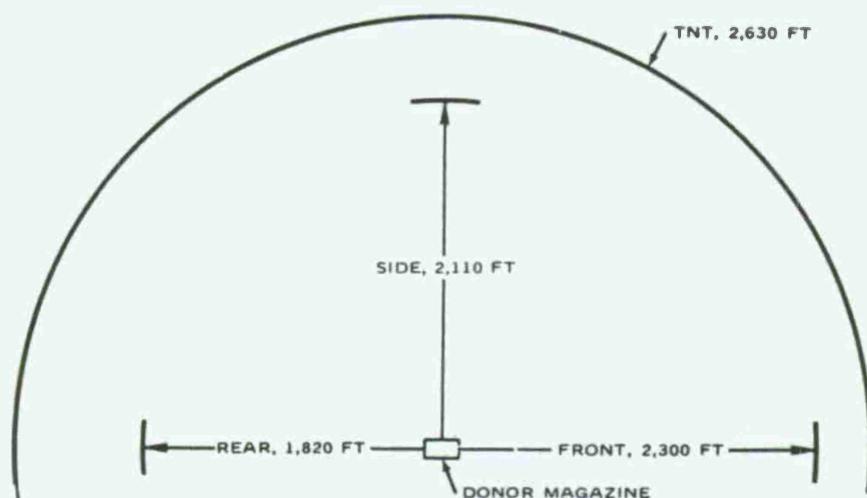
Figure 69 shows 1-psi overpressure values to the front, side, and rear of the donor magazine, derived from BRL gauge data, and a computed value based on 200,000 pounds of TNT. The three derived values were obtained by using $W^{1/3}$ values derived by averaging the BRL gauge overpressure and impulse values and multiplying by a scaled distance factor of 45 corresponding to a 1-psi overpressure level in standard curves prepared by C. Kingery of BRL (Ref. 4). These values of 2,300, 2,110, and 1,820 feet are slightly higher than those based solely on the 1-psi overpressure levels recorded by the BRL gauges. The computed value was determined without reduction to an equivalent weight; that is, $200,000^{1/3} \times 45 = 2,630$ feet.

Using this value, $W^{1/3} = 49.5$, and the predicted position of the 1-psi overpressure level would be 49.5×45 or 2,230 feet in all directions from the donor magazine.

FIG. 69. Comparison of 1-psi Overpressure Distances for ESKIMO I Test With Distance for 200,000 Pounds of Unconfined TNT.

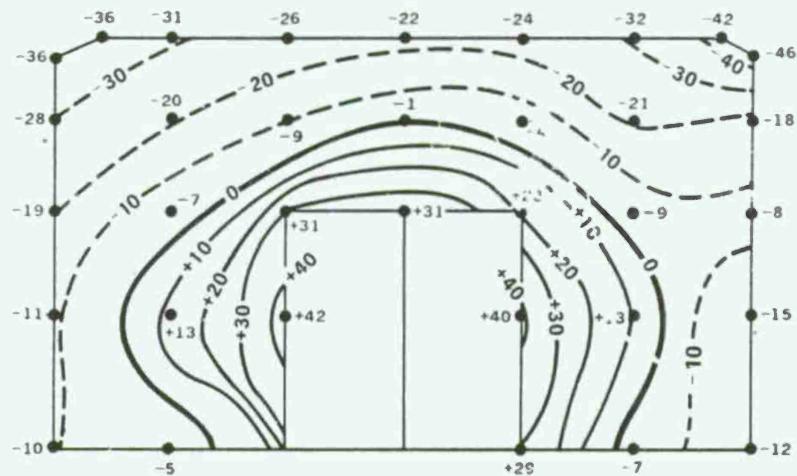
FIG. 77. Movement of Headwall of North Acceptor Igloo. A plus value shows movement away from the donor magazine; a minus value shows movement toward. The units are in hundredths of feet.

Note that the headwalls appear to have responded in different ways at each of the three sites measured. It is apparent from visual observation and from examination of the measurement data at the north and south sites that the steel arch acted as a reaction line resisting headwall movement. The steel arch yielded somewhat but, curiously, this effect was more pronounced at the south igloo, where measured movement at the top of the arch was 2.5 to 3 inches.

The movement shown in Fig. 77, 78, and 79 does not represent the maximum motion experienced by the headwalls. For example, there was a space approximately 0.2 feet wide between the back of the south headwall and the earth cover at the top left corner and a similar space 0.1 feet wide at the top right corner indicating movement greater than the permanent displacement. Similar but less marked evidence of earth cover compression was seen at the other acceptor igloos. This earth cover disturbance at headwalls may be seen in an overhead photograph (Fig. 31).

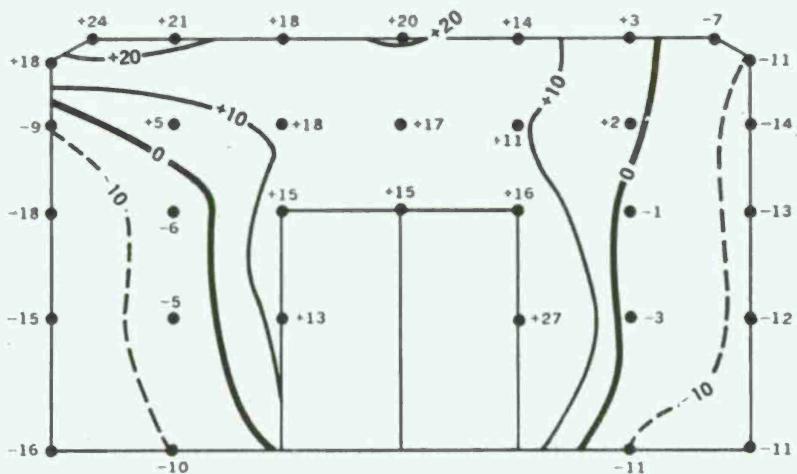
FIG. 78. Movement of Headwall of South Acceptor Igloo. A plus value shows movement away from the donor magazine; a minus value shows movement toward. The units are in hundredths of feet.

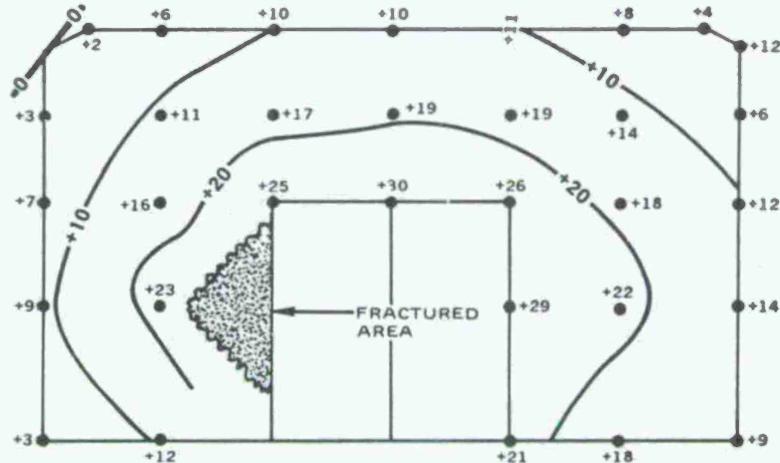
FIG. 79. Movement of Headwall of West Acceptor Igloo. Plus values show movement away from donor magazine; one point (upper left) showed no movement. The units are in hundredths of feet.

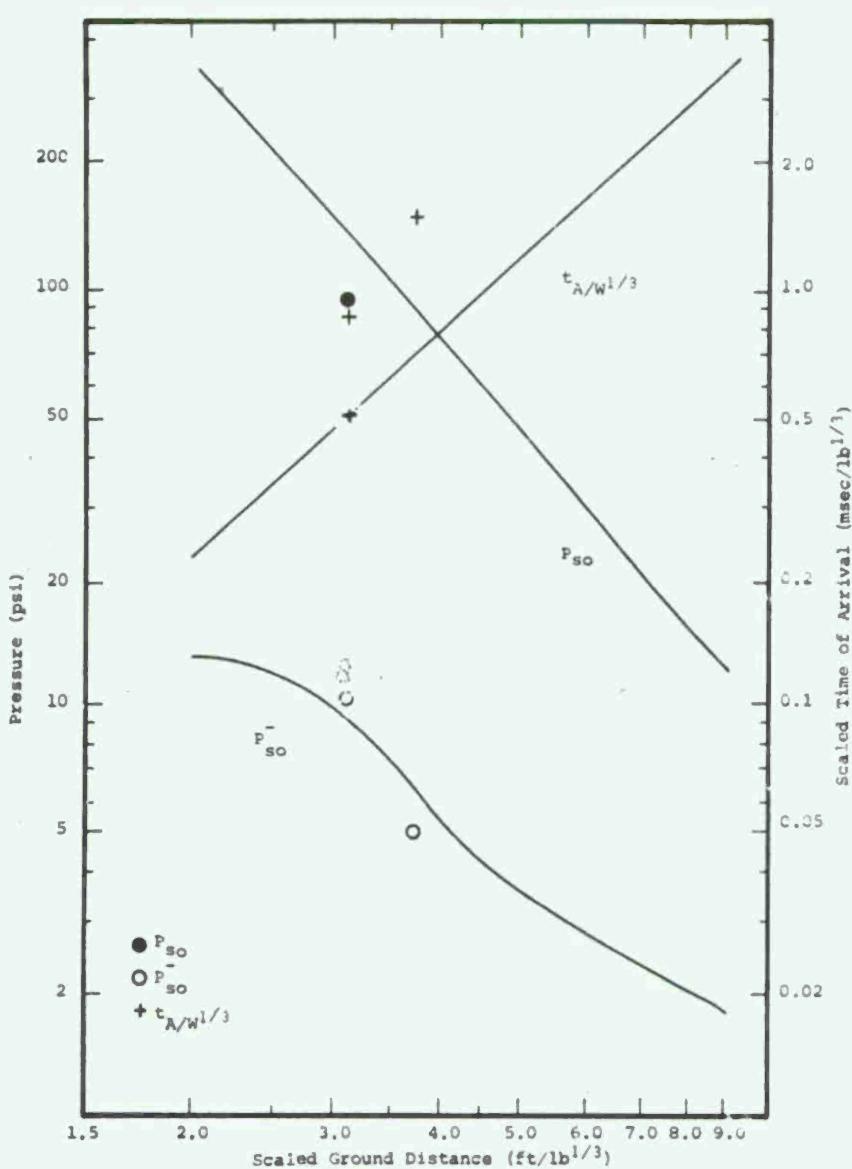
The time off-set discussed above is not critical for evaluation of far-field measurements but is of importance for interpretation and correlation of near-field results, i.e., those measurements taken near the acceptor igloos. For example, all effective cube-root explosive weights estimated from near-field positive phase measurements (listed in Table I) are smaller than the average value of 46.5 estimated from far-field results. Effective weights, estimated from time of arrival data, were obtained by selecting values of effective cube-root weight such that calculated points for scaled arrival time and distance agree with the idealized, scaled time of arrival curve of Fig. 7. Effective explosive weights were also estimated from results of the external transducer located at the base of the northeast concrete magazine. The recorded side-on pressure (85.4 psi) corresponds to an effective cube-root weight of 41 and the arrival time to 35 $W^{1/3}$ for a surface burst; 46 $W^{1/3}$ and 41 $W^{1/3}$, respectively, for an air burst.

Effective weight calculations based on near-field measurements are not intended to conclusively determine donor charge. They do, however, indicate that blast conditions experienced by the igloos were not as intense as might be expected from far-field measurements.

Fig. 7. Comparison of Converted Eskimo I Data with Ideal Surface Burst Curves
